**Surface Examination Report**

Report Date: September 26, 2000

Lands: Section 2, T. 17 S., R. 13 W., SLB&M, Millard County Utah, All Gemstone/Fossil  
Leases in Section 2, See accompanying map depicting leased lands.

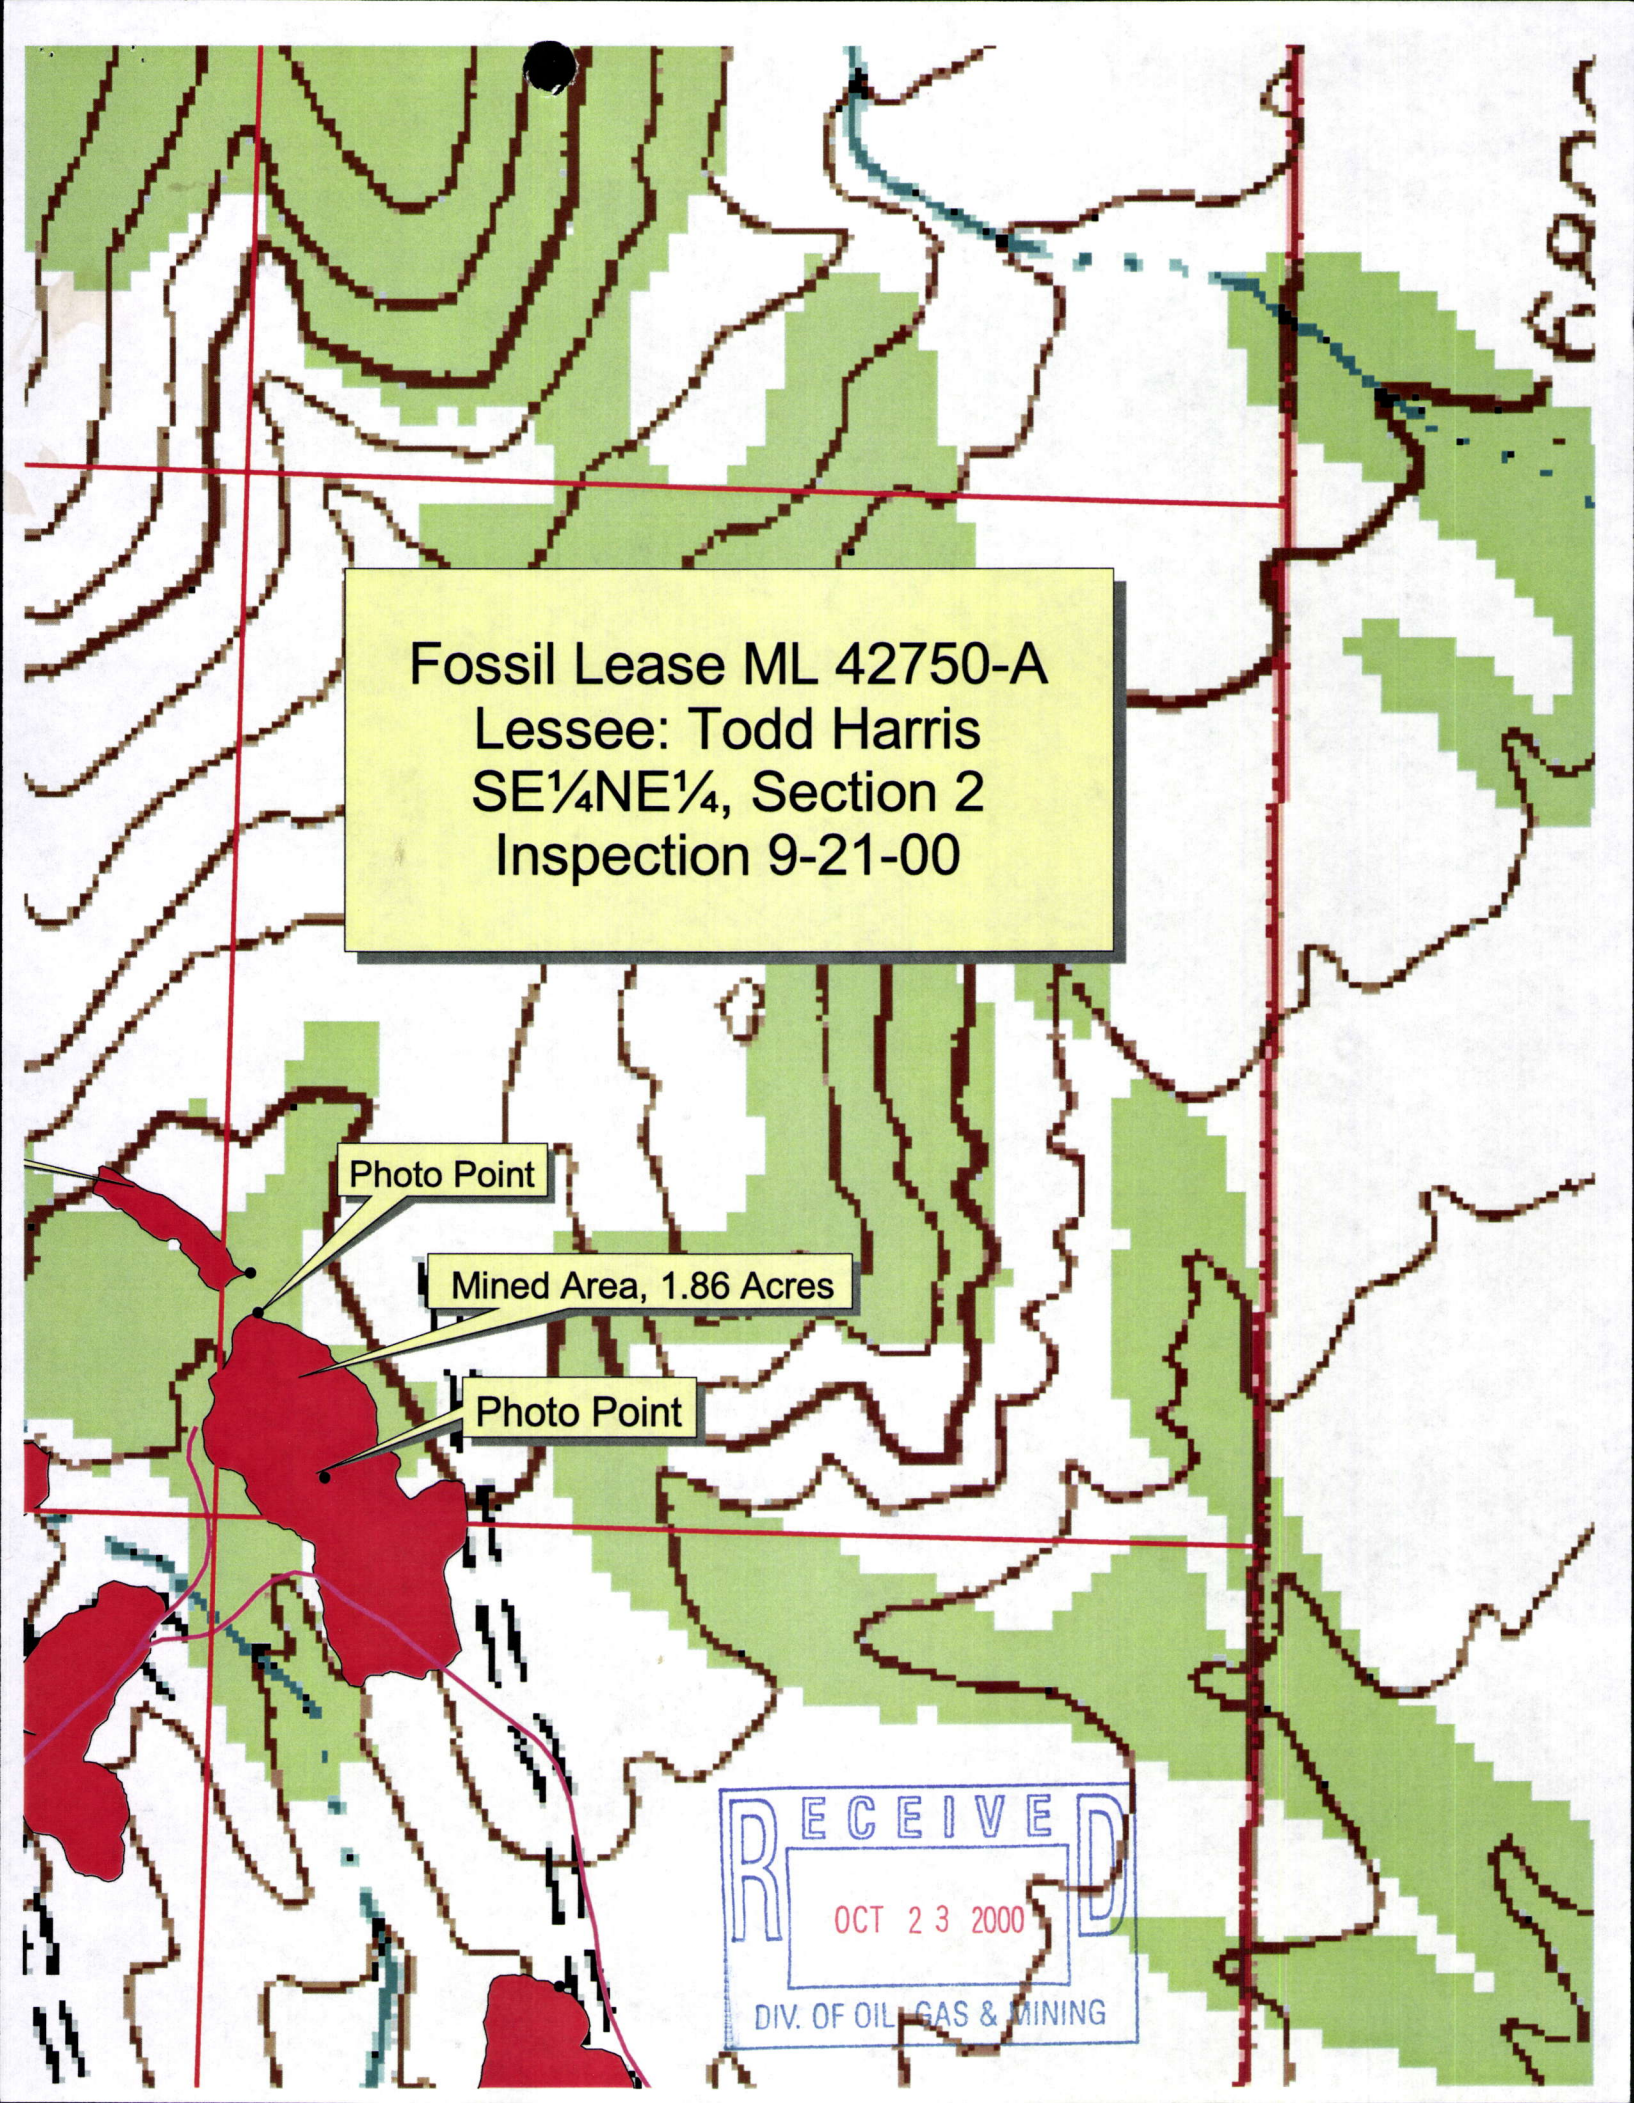
Fossil Lease ML 42750-A  
Lessee: Todd Harris  
SE $\frac{1}{4}$ NE $\frac{1}{4}$ , Section 2  
Inspection 9-21-00

Mined Area, 1.86 Acres

ML 42750-A encompasses the SE $\frac{1}{4}$ NE $\frac{1}{4}$  of Section 2 and was assigned to Todd Harris and Marlow Cropper out of ML 42750 by Robert Drachuk. The map labeled Fossil Lease ML 42750-A shows the detailed results of the GPS survey of the mine related disturbances associated with this lease. There is only one excavation on ML 42750-A which, in its entirety, encompasses 1.86 acres. Half of this disturbance, .93 acres, falls within the boundaries of ML 42750-A. Presently the lessee, Marlow Cropper, has posted with the Trust Lands Administration a reclamation bond, in the form of a certificate of deposit, certificate # 058-909007, issued by Zions Bank, in the amount of \$2,500.00. At this time the lessees are adequately bonded for all disturbances that fall within the lease lands encompassed by ML 42750-A. Accompanying this report are captioned photographs #'s 15 thru 17, which depict the present surface conditions on the leased lands.

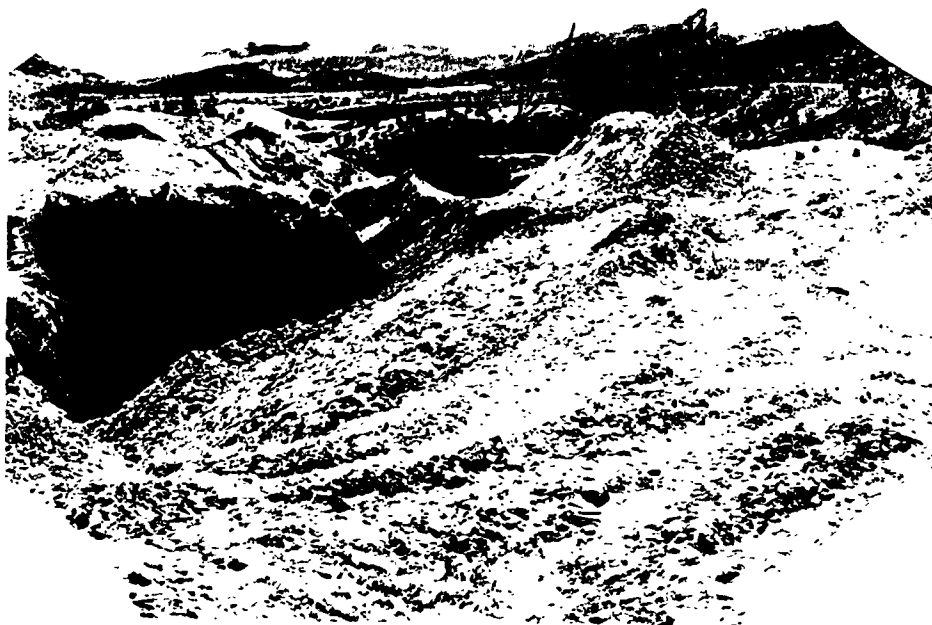
Photo. # 3, Looking south from the north edge of the .96 acre mined area on lease ML 26068. Arrow 1 shows the location of the Loy Crapo, U-Dug quarry on ML 26068-A. Arrow 2 shows the photo position at the south end of the .96 acre mined area.

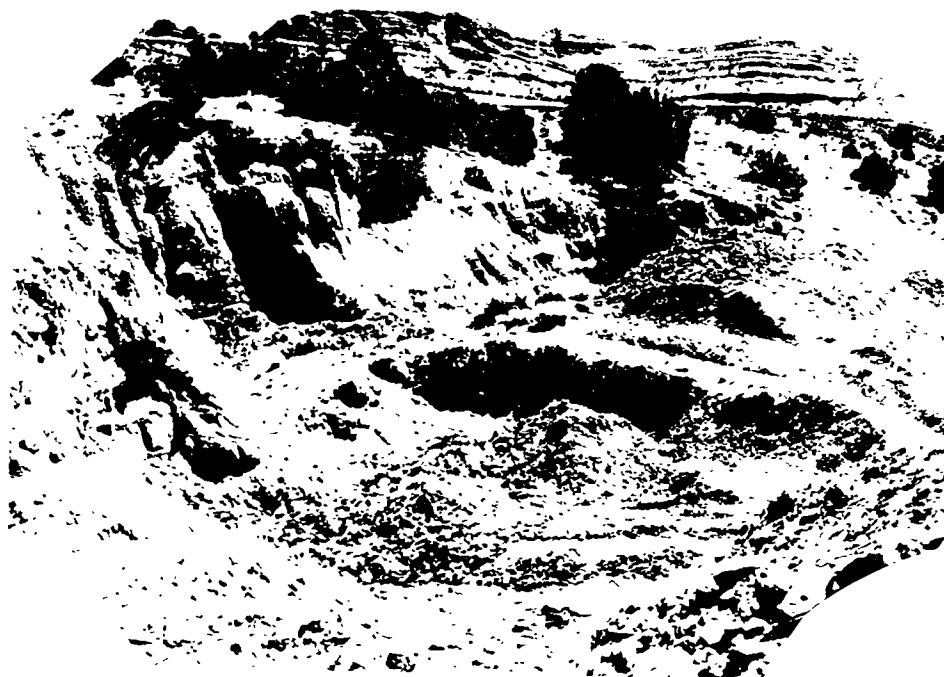
Photo. 4, Looking south from the photo point that is in the center of the 1.86 acre mined area, on the north boundary line of ML 26068. This photo shows the south half of the 1.86 acres mined area which falls within the boundary of ML 26068.

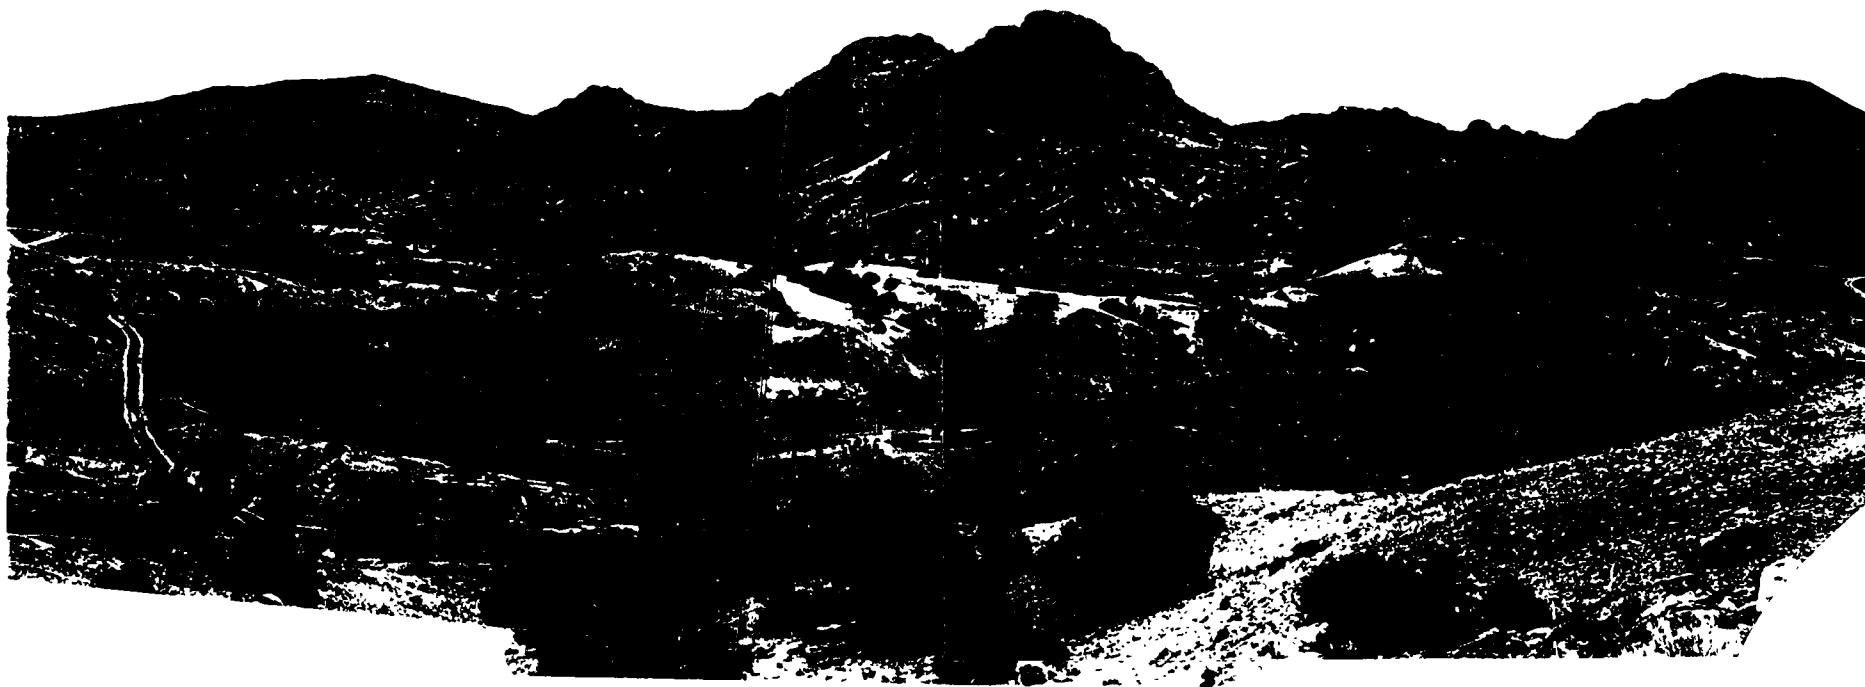
Photo # 7, Looking east onto the east side of the large mined area operated by U-Dig on ML 26028-A. The shed in the center of the photograph is used as the office for the U-Dig operation. Note the disturbed area, shown as a dashed line, "horse shoes" around the undisturbed hill in the center of the photograph. The arrow shows the location of the excavation depicted in photo # 6.

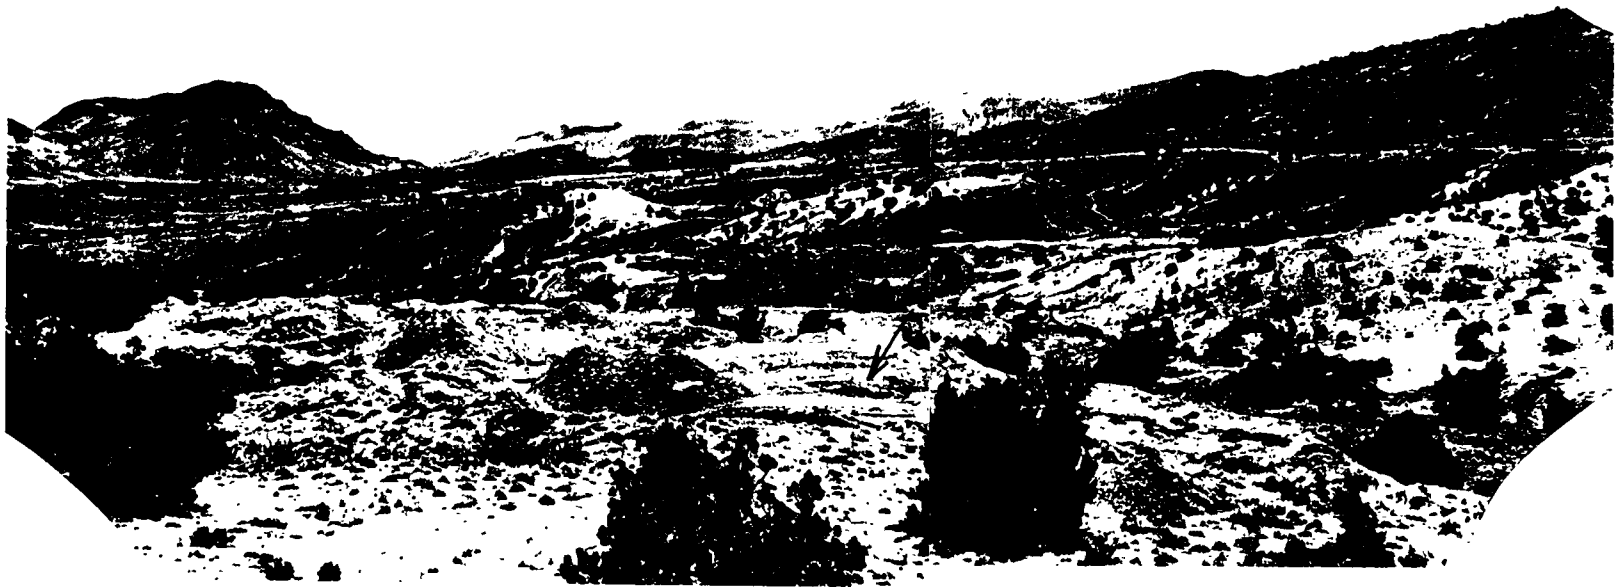
Photo. # 8, Looking southwest from the southern most photo point on the central excavation of ML 26068 onto the southern excavation on ML 26069 in the foreground and the east side of the U-Dig operation, ML 26068-A, dashed line, in the background. The arrow shows the location of the graded area on ML 26068 which is depicted in Photo # 1.

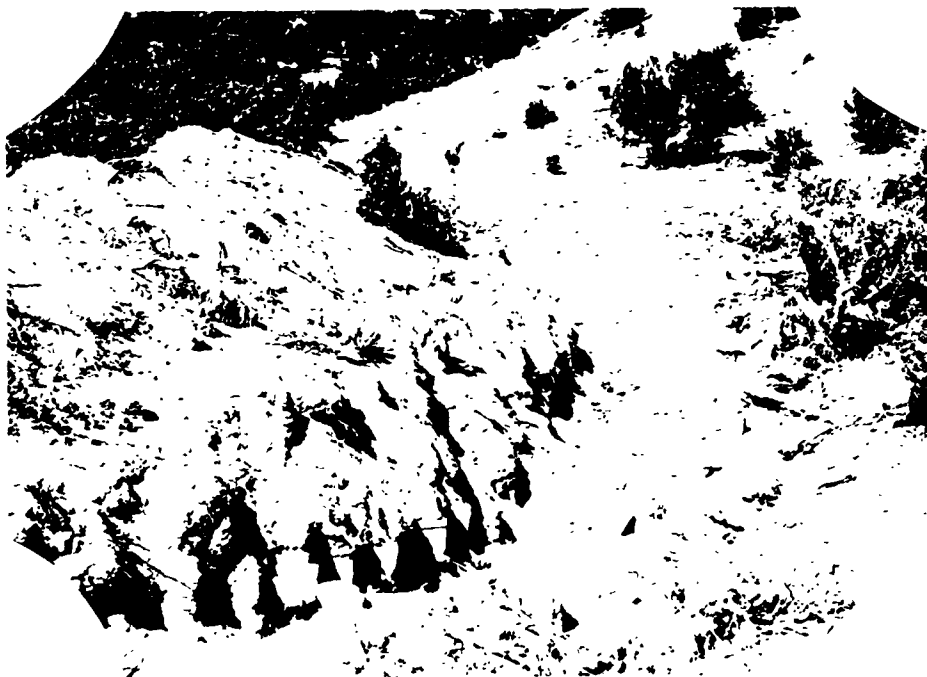
Photo. # 10, Looking northwest from the south end of the recently created trench that encompasses .21 acres of disturbance on ML 42750.

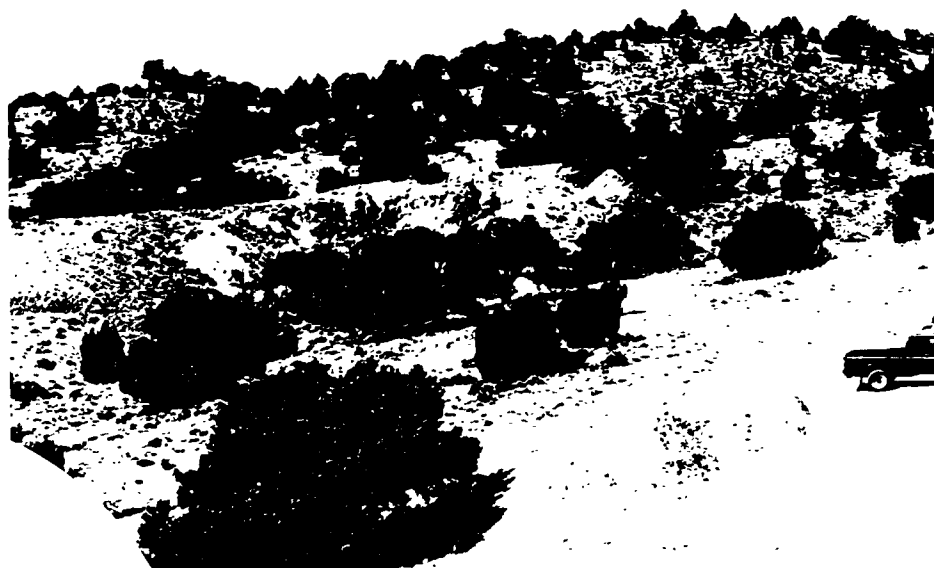
Photo. # 11, Looking west from the center of the large excavation that lies partially on ML 26068 and ML 42750-A. This disturbance encompasses approximately .22 acres.

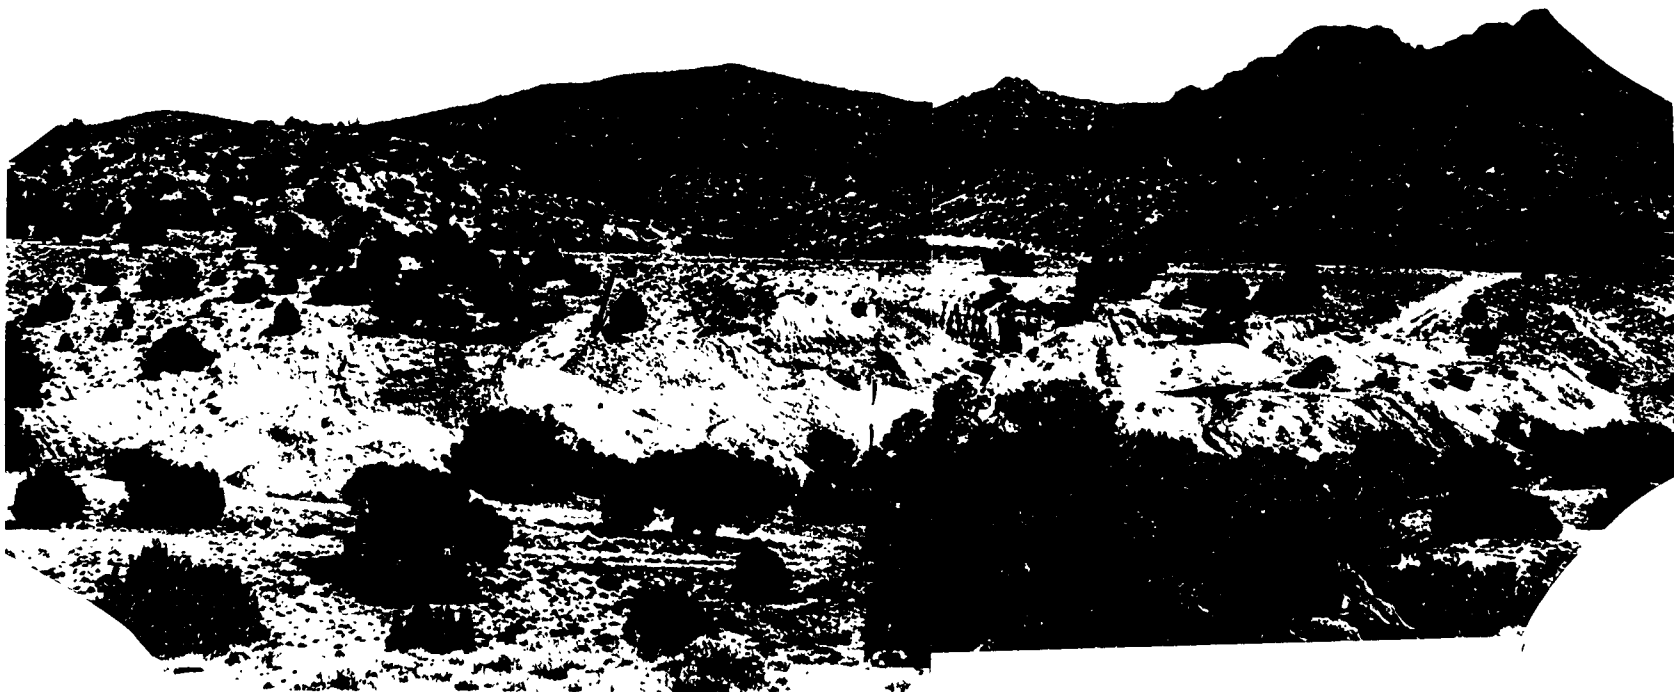
Photo. # 15, Looking east onto the main excavation area on ML 42750-A. The dashed line approximates the location of the boundary line between ML 42750-A and ML 26028. The arrow shows the photo point, at the top of the highest waste pile, from where photos 11, 12 and 17 were taken.

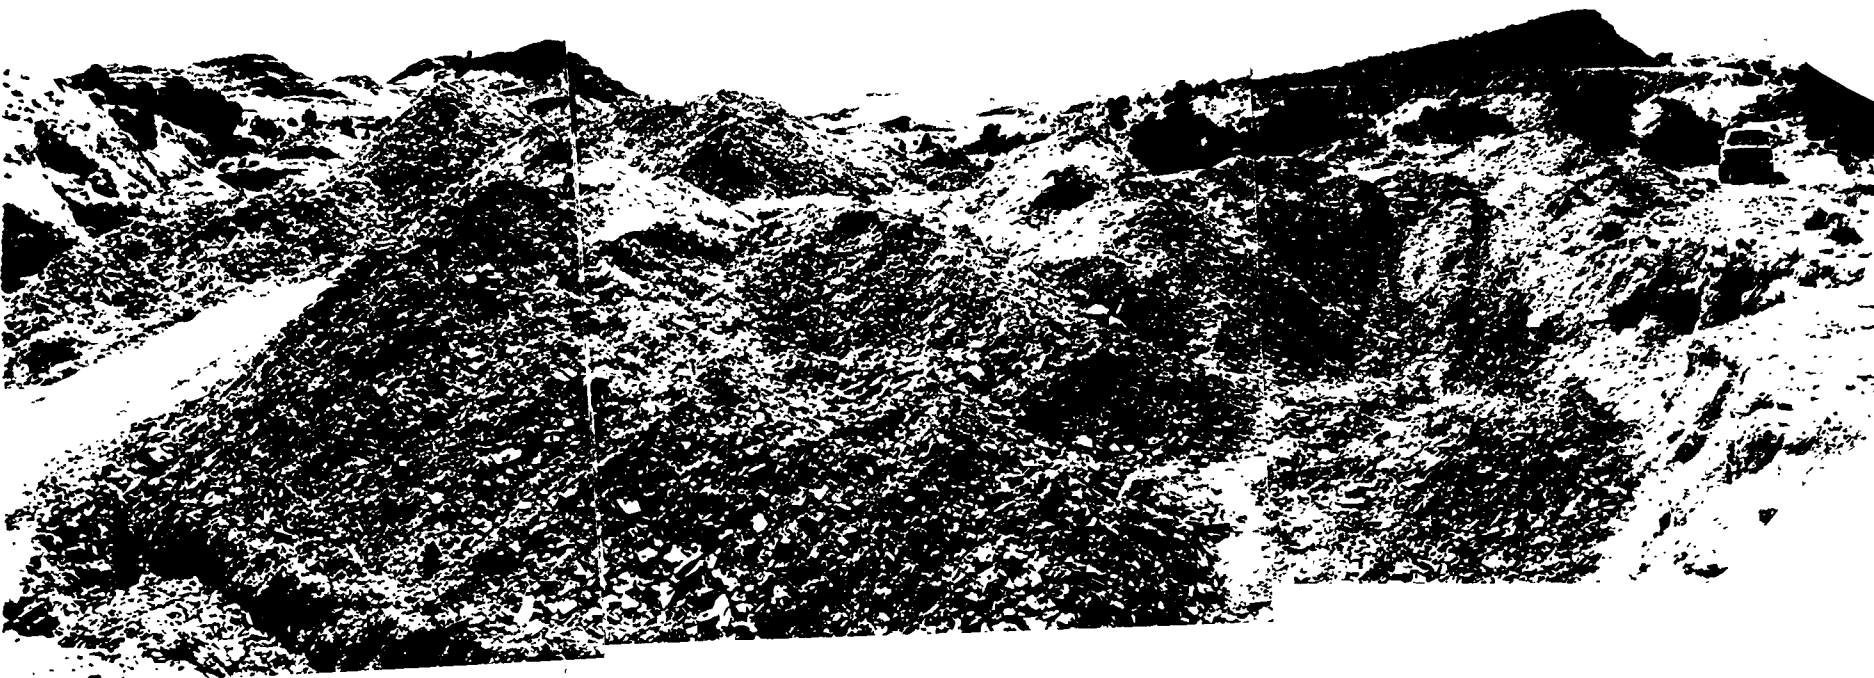
Photo. # 16, Looking south from the north end of the main excavation on ML 42750-A onto the northern half the excavation that falls within the boundaries of the SE $\frac{1}{4}$ NE $\frac{1}{4}$  (ML 42750-A). The arrow shows the location of the photo point from where photos 11, 12 and 17 were taken. The southern half of this excavation, which is obscured by the waste piles, falls on lease ML 26068.

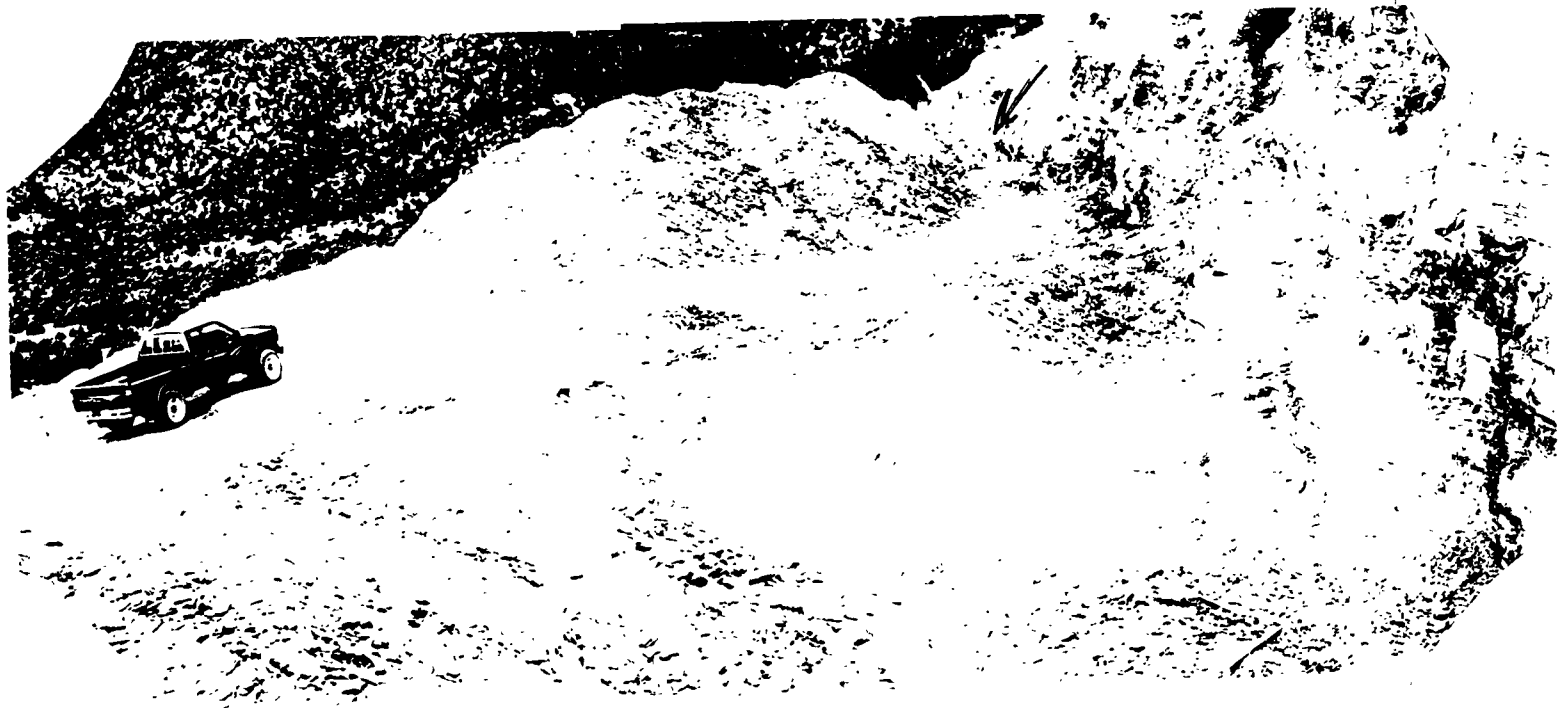
Photo # 19, Looking north onto the northern half of the excavation on ML 43395 from the northern boundary of the graded area near the center of the disturbed lands. The arrow shows the location of active mining

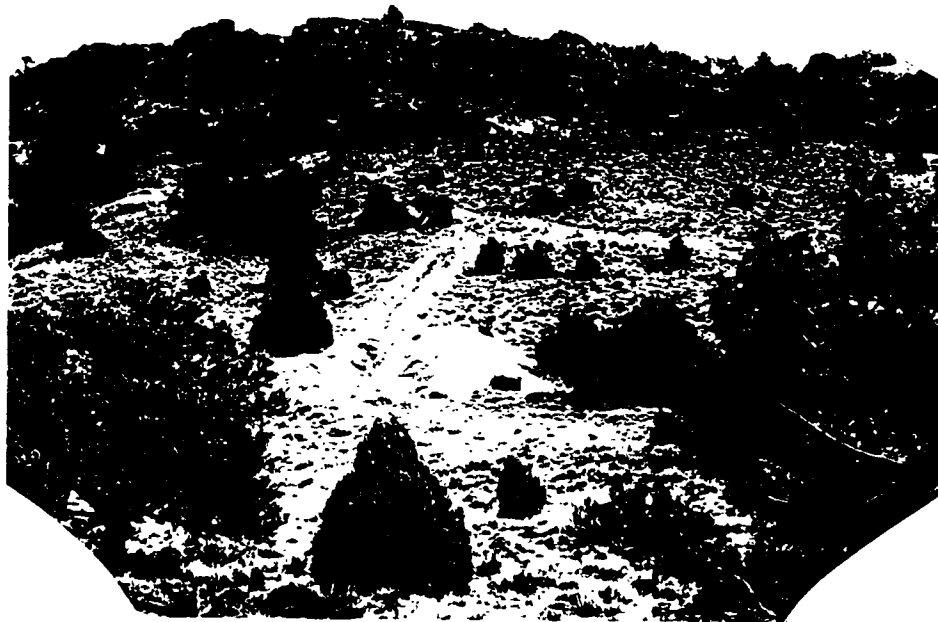
Photo. # 21, Looking east from the main access road, that traverses north/south through Section 2, onto the trench on ML 44287. This trench was not mapped with the GPS.

ML 44287 encompasses the SE $\frac{1}{4}$ NW $\frac{1}{4}$  of Section 2 which is presently under lease to Conrad Pugh. The map labeled Fossil Lease ML 44287 shows a detail of the present surface disturbance on the leased lands. The lessee conducted exploration trenching on the leased lands which created a surface disturbance of approximately 125 feet by 8 feet, or .02 acres. Presently the lessee has posted with the Trust Lands Administration a reclamation bond, in the form of a cash deposit, in the amount of \$2,500.00. At this time the lessee is adequately bonded for all disturbances that fall within the lands encompassed by ML 44287. Accompanying this report is captioned photograph # 21, which depict the present surface conditions on the leased lands.
